Report No. UT-12.14

Plan Recommendation for Traffic Sign Management

Utah Department of Transportation
Research and Innovation Division

Department of Civil & Environmental
Engineering - Utah State University

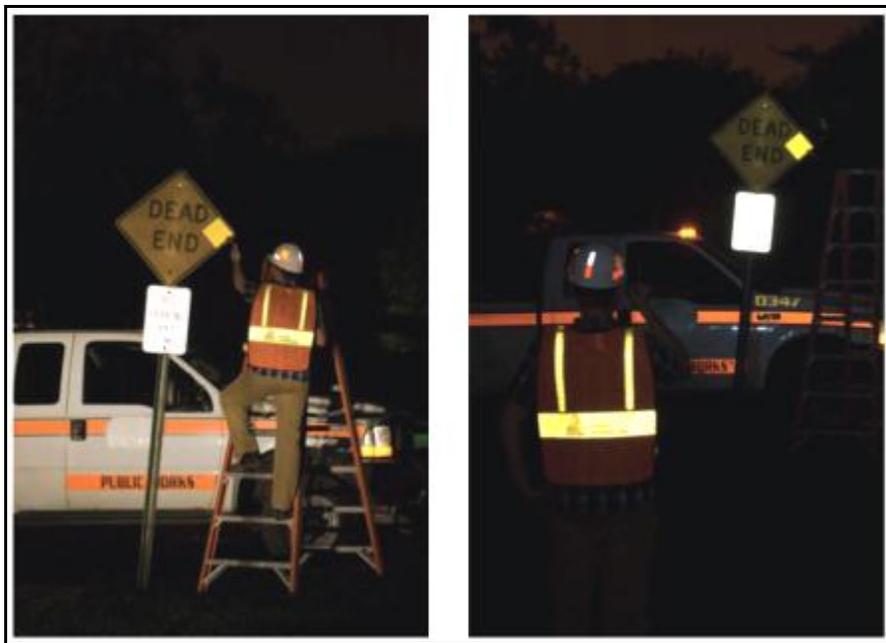
Comparison panel procedure require that inspectors clamp small sheeting panels on traffic signs that appear to perform below minimum retroreflective levels and determine if the sign is as bright as the panel. Typical dimensions for comparison panels are 6” by 6” sheeting samples (36). Unlike the calibration sign procedure inspection crews do not need to calibrate their eyes prior to beginning the inspection. Instead they identify signs that appear to be near the minimum retroreflectivity levels and clamp the panel to the sign. Using a flashlight of adequate brightness an inspector assessed the sign’s retroreflectance and determines if it exceeds the panel, as shown in Figure 0.11.

Figure 0.11 Example of Comparison Panel Procedure (36)

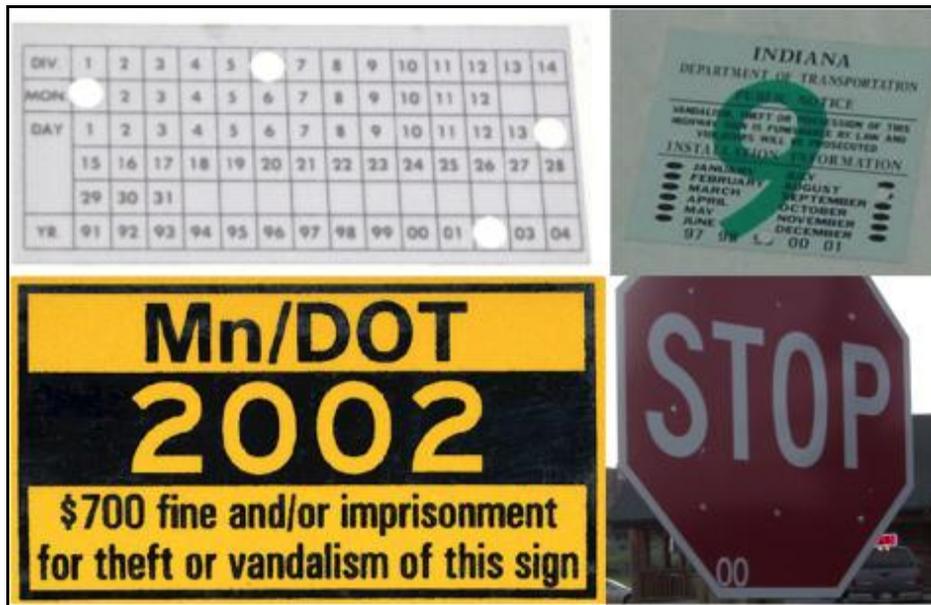
date information. Installation dates can appear either on the sign itself and/or can be recorded in a centralized agency database. Examples of installation stickers utilized by other agencies are shown in Figure 0.16. Just like the other management methods the major hindrance in the expected life method is forecasting the deterioration of retroreflective sheeting in different environments.

Figure 0.16 Installation Stickers

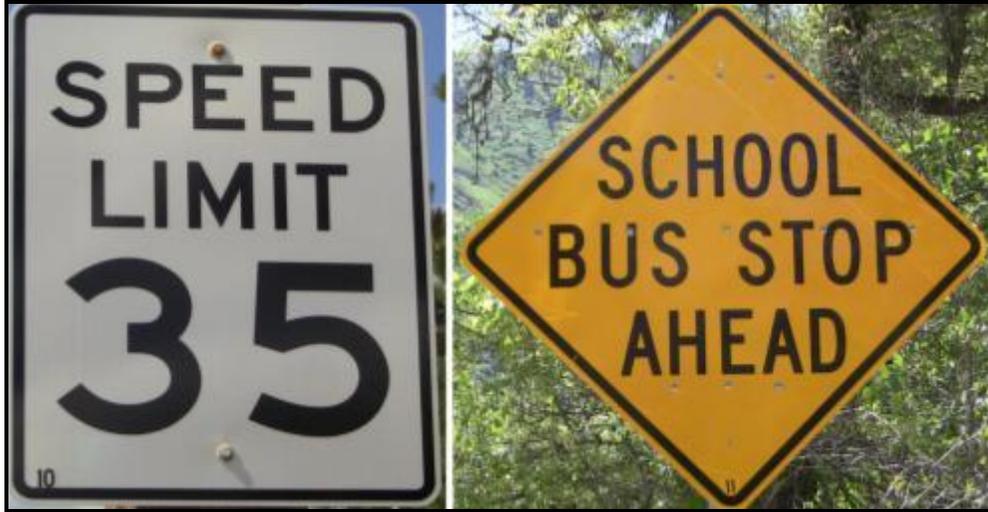
Figure 0.2 UDOT Installation Stickers

Installation date is the date the sign was placed in service, identified by known blanket replacements, UDOT databases information or by the presence of installation stickers. Since 2008, UDOT has mandated that all signs placed into the field have an installation sticker on both the front and back of the sign. Typically the sticker on the front of the sign has a transparent background with a black legend for the year it was installed, whereas the back contains the month and year of installation and the company that constructed the sign. Although mandatory since 2008, compliance with this policy was not consistently adopted by the stations and contractors installing signs for UDOT.

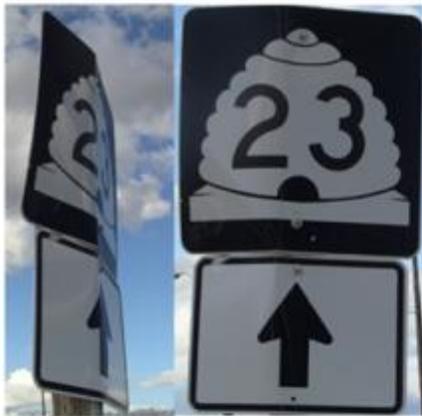
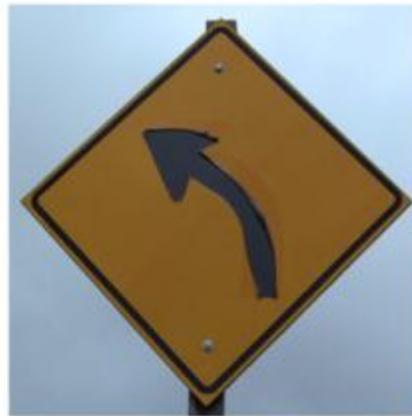
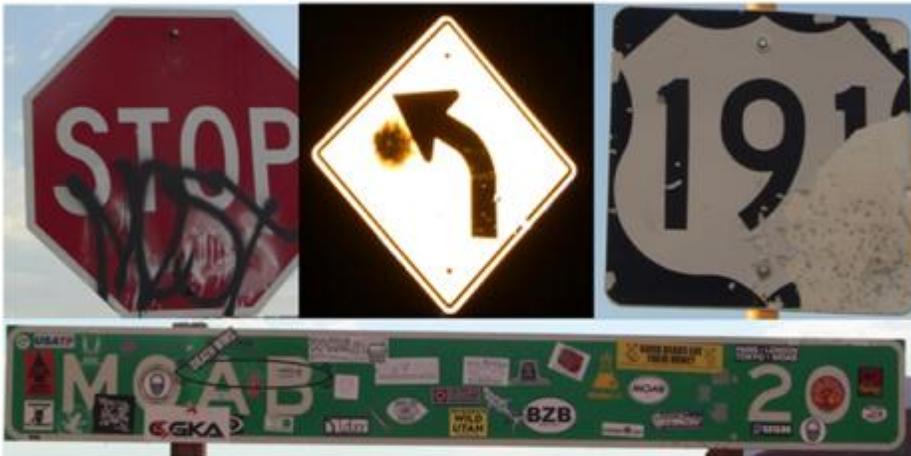
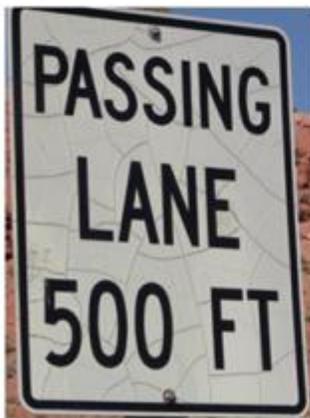
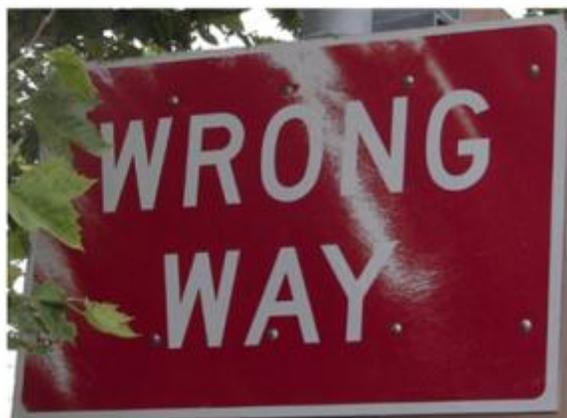
Figure 0.4 Damage Types

Damage major and damage minor refer to the condition of the sign and damage that was present. In the field, damage was identified by the degree and was aggregated into five categories of Peeling, Cracking, Bending, Vandalism and Other, shown in Figure 3.4. Detailed information on the distinction between the different damage categories and major or minor severity is discussed in Appendix A: Major and Minor Damage Examples.

A. Bending Damage

B. Peeling Damage

C. Vandalism

D. Cracking Damage

E. Other Damage Types

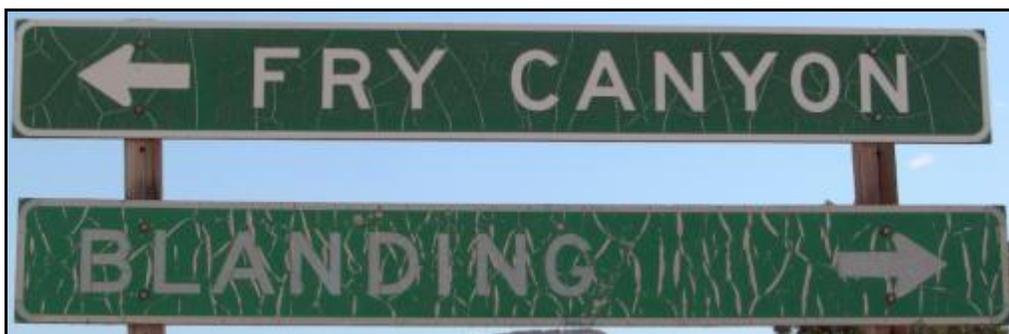
Figure 0.2 Failed Type I Green Sign

The mean retroreflectivity level for green Type I sheeting was 4 cd/lx/m² which is 3 cd/lx/m² less than the required retroreflectivity level. Only 15 green Type I traffic signs were surveyed and 11 did not meet the minimum retroreflectivity levels. An example of a failed green Type I traffic sign is shown in Figure 0.2. According to the MUTCD white Type I sheeting shall not be utilized on the legend of a traffic sign, therefore no new Type I guide signs should be introduced into the sign population. The maximum recorded retroreflective measurement was 14 cd/lx/m².

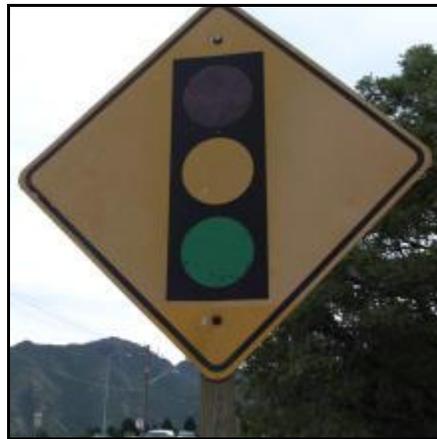
Figure 0.3 Failed Type I Yellow Sign

By the conclusion of the collection effort 35 yellow Type I signs were measured. The mean retroreflectivity was 23 cd/lx/m² with a maximum measurement of 75 cd/lx/m². More than 80 percent of the Type I yellow signs failed the minimum retroreflectivity levels. The root cause

of the majority of these failures is the minimum production requirements for yellow Type I sheeting. According to ASTM D 4956-11a the minimum required level of retroreflectivity for a yellow Type I is 50 cd/lx/m^2 which is identical to the minimum level specified in the MUTCD (9). This leaves little to no room for deterioration of the sheeting before it drops below the minimum levels. For this reason Type I yellow traffic signs shall not be used for any traffic sign application. Figure 0.3 shows an example of a fail Type I yellow traffic sign.

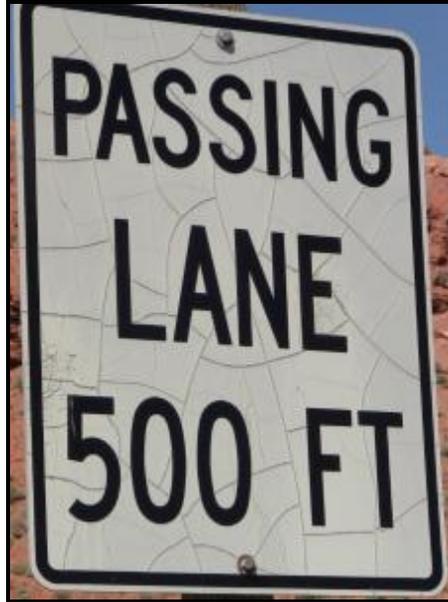
Figure 0.4 Cracking Damage on Type I Sheeting

The majority of failing Type I signs exhibited type of damage that was commonly found in this sheeting type. The damage type was categorized as cracking and an example is shown in Figure 0.4.

This was assumed to occur when the sheeting face deteriorated to the point that the face became powdery and brittle. This type of damage is easily recognizable under daytime inspections. Over 60 percent of the Type I signs sampled exhibited this cracking damage. Of the signs with cracking damage present 86 percent were found to be below the minimum requirements for the relevant sheeting color.

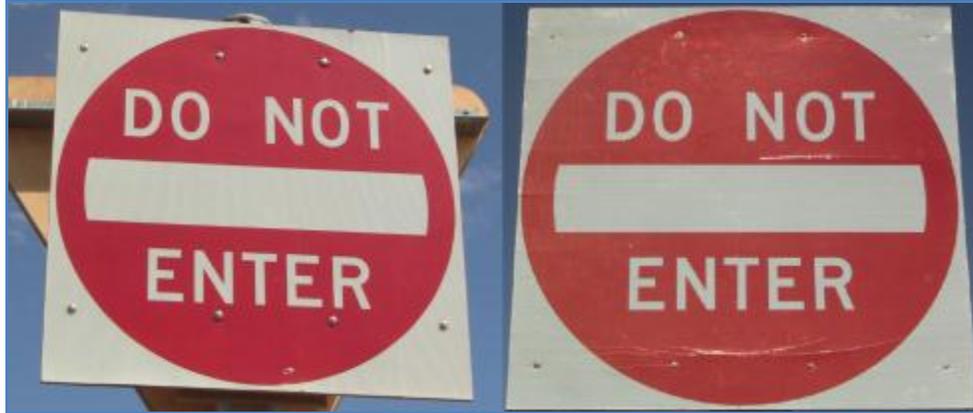
Retroreflective measurements for Type III red sheeting ranged from 2 cd/lx/m^2 to 95 cd/lx/m^2 . The overall average was 41 cd/lx/m^2 with a standard deviation of 21. At the completion of the sample survey there was a total of 150 Type III red traffic signs with only seven failures. As stated in the MUTCD red traffic signs must maintain a minimum background retroreflectivity greater than or equal to 7 cd/lx/m^2 and a legend retroreflectivity of 35 cd/lx/m^2 . In addition to these minimum levels a contrast ratio between the legend and the background must be greater than or equal to three. Of these seven failures only one was the result of not meeting the required contrast ratio. The average observed contrast ratio was 12. Figure 0.6 shows different examples of Type III failures.

Figure 0.6 Failed Type III Red Signs

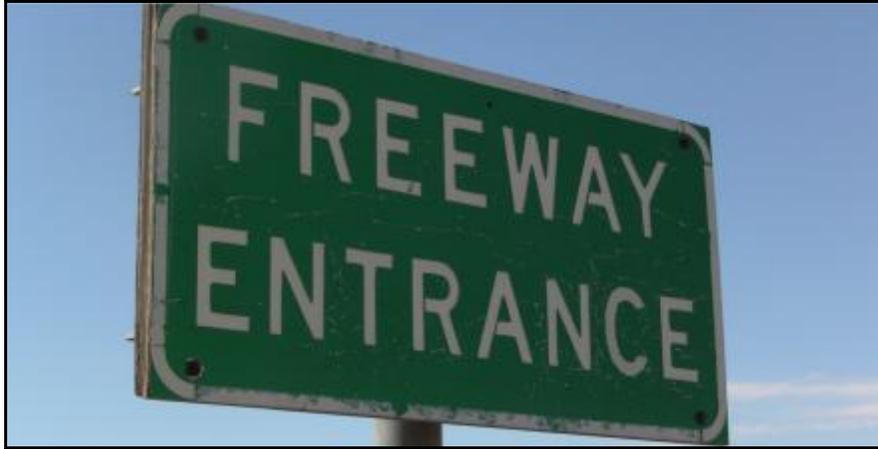
Overall the Type III green population measured during the sample survey was performing above the minimum levels. Only two percent of the 243 measured signs failing to meet the minimum levels. The minimum retroreflectivity level that must be maintained by Type III green sheeting is 15 cd/lx/m². Similar to red background, green traffic signs must maintain a specific legend brightness which is 120 cd/lx/m². Only one of the four Type III green failures was due the legend measurements being below the minimum level. Figure 0.7 shows an example of a legend failure. The average background measurement for Type III green sheeting was 47 cd/lx/m² with values ranging from 6 to a maximum of 67 cd/lx/m² with a standard deviation of 10. Overall the legend measurements were performing above the minimum levels with an average measurement of 282 cd/lx/m².

Figure 0.7 Failed Type III Green Sign

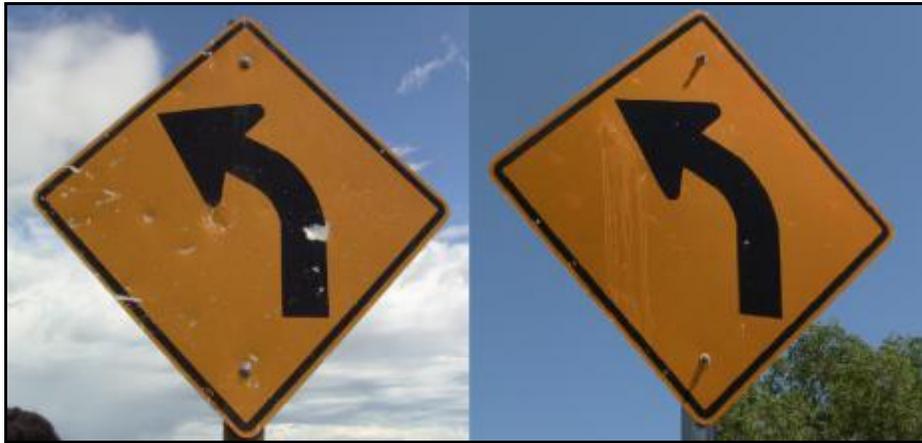
had a standard deviation of 61. Examples of Type III yellow traffic signs the performed below the minimum retroreflectivity levels are shown in Figure 0.8.

Figure 0.8 Failed Type III Yellow Sign

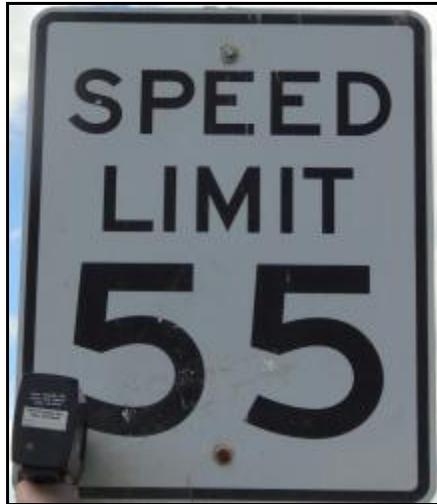
Figure 0.9 Lowest Performing Type III White Sign

White Type III was the largest color and sheeting type combination observed during the sample survey with 322 traffic signs. Overall Type III sheeting is performing exceptionally well and had no underperforming signs observed during the collection effort. Although there is no distinction between regulatory and non-regulatory white traffic signs with respect to the minimum retroreflectivity levels, regulatory signs have a higher priority within UDOT maintenance procedures. Due to the frequency of collection at roadway junctions 67% of the Type III white population consists of non-regulatory traffic signs. The average measured retroreflectivity was 275 cd/lx/m^2 with values ranging from 91 to 346 cd/lx/m^2 with a standard deviation of 35. Figure 0.9, displays the Type III white with the lowest measured retroreflectivity, the reason for the low retroreflectivity is a sizable paintball impact in the lower left corner.

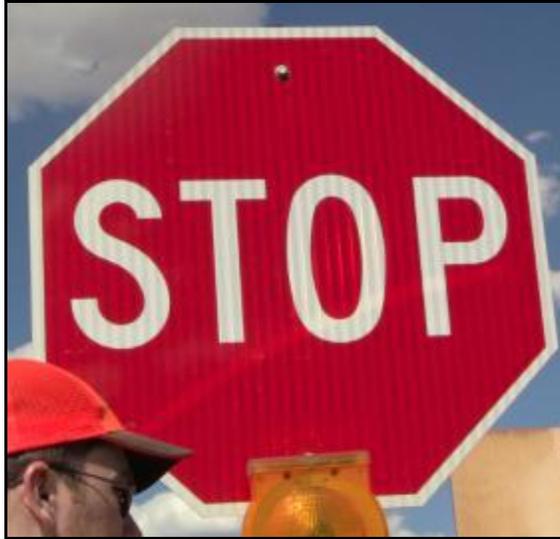
Figure 0.11 Failed Type III HIP Red Sign

At the completion of the sample survey a total of 31 red Type III HIP traffic signs were measured. The majority of Type III HIP had retroreflectivity measures far greater than the minimum levels. The only Type III HIP failure is a red stop sign that did not meet the required contrast ratio, shown in Figure 0.11. Even with a legend retroreflectivity measurement of 647 cd/lx/m², it only produced a contrast ratio of 2.88 due to the relative high retroreflectivity of the background sheeting.

The average contrast ratio for red Type III HIP sheeting was 7.72 compared to Type III which was 11.86. On average the Type III HIP background retroreflectivity was 3 times higher than Type III, compared to a 2.3 times increase in the retroreflective legend. Therefore, even with higher performing sheeting failures can still occur. The average measured retroreflectivity for red Type III HIP was 122 cd/lx/m^2 with values ranging from 15 to 225 cd/lx/m^2 with a standard deviation of 53.

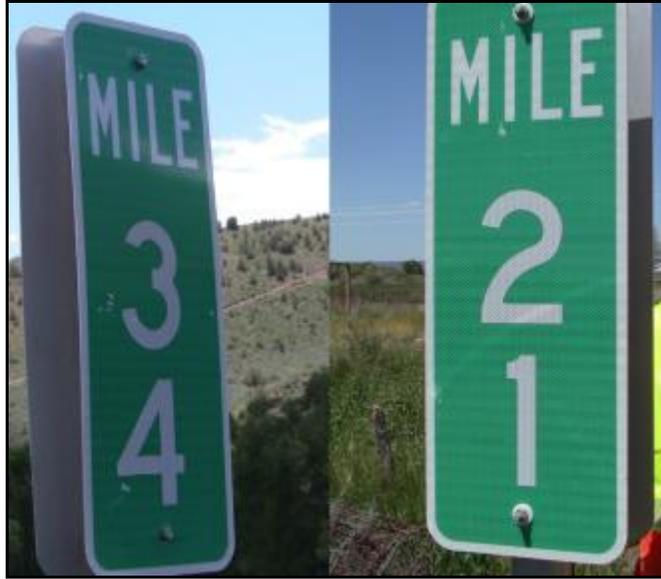
A total of 48 Type III HIP green traffic signs were observed during the course of the sample survey. None of which failed the current minimum retroreflectivity levels. The average measured retroreflectivity was 100 cd/lx/m^2 with values ranging from 47 to 148 cd/lx/m^2 and a standard deviation of 21. Although it is no longer included in the current MUTCD standards in the initial minimum retroreflectivity levels a contrast ratio of 4:1 was required for guide signs. If this standard was still in place 60 percent of the Type III HIP green signs would not meet this criterion. Due to green sheeting being a relatively dark background color it is important that a noticeable contrast is present between the legend and the background. UDOT should take this into consideration to ensure proper message conveyance and reaction time for motorists. Examples of low contrast ratio present on Type III HIP green sheeting are shown in Figure 0.12.

Figure 0.12 Low Contrast Ratio Type III HIP Green Signs

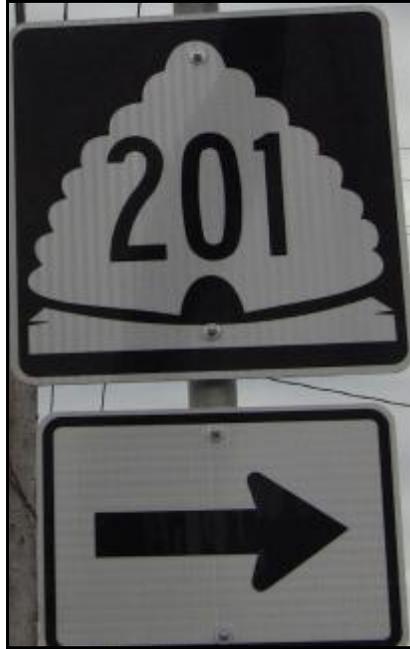
Figure 0.14 White Type III HIP with Different Sheeting Orientations

During the collection effort 77 white Type III HIP traffic signs were observed. White sheeting was performing far above the minimum levels with an average measured retroreflectivity of 642 cd/lx/m², it had a standard deviation of 139 with values ranging from 270 to 878 cd/lx/m². The reason for the large spread in retroreflectivity measurements is improper sheeting orientation. A small set of the population was observed at rotations of 90 degrees from the proper orientation. An example of the 90 degree rotation is shown in Figure 0.14.

The M1-5 on the top has its sheeting placed at the proper vertical orientation, whereas the M6-1R is rotated 90 degrees from the optimum orientation. The measured retroreflectivity for the state route sign was 811 cd/lx/m² compared to the 699 cd/lx/m² on the directional arrow. Improper sheeting rotation was typically seen on the smaller traffic signs maintained by UDOT. At the completion of the sample sign survey 30 percent of the Type III HIP white population was classified as regulatory white signs.

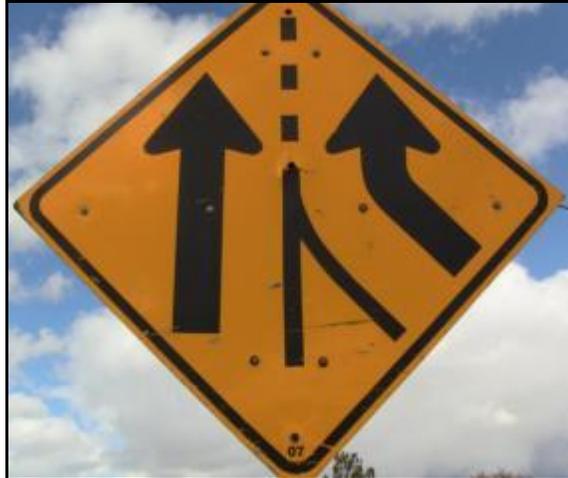
Figure 0.17 Damage Type IX Yellow Sign

A total of 70 Type IX yellow sheeting sign were measured by the completion of the sample survey. The average measured retroreflectivity was 390 cd/lx/m^2 with values ranging from 208 to 584 cd/lx/m^2 and a standard deviation of 101. Even though Type IX has less rotational sensitivity when compared to Type III HIP, Type IX yellow sheet had a greater coefficient of variation. This might be caused by the age of the Type IX yellow sheet measured during the sample survey. In total 36 of the 70 Type IX had installation dates ranging from 2005 to 2011. The lower measure retroreflectivity were found and signs that were damaged or aged. Figure 0.17, shows an example of a damaged Type IX yellow sign that was installed in 2007.

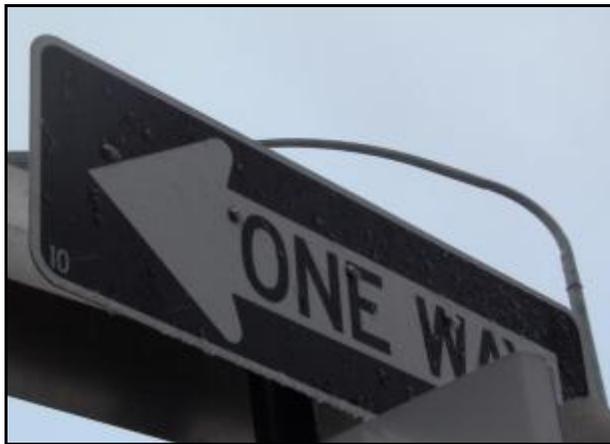
Figure 0.18 Poor Performing Type IX White Sign

There were a total of 45 Type IX white traffic signs that were measured during the sample survey. As expected these signs were performing far above the minimum levels. The average measured retroreflectivity was 436 cd/lx/m² with values ranging from 236 to 579 cd/lx/m² and a standard variance of 97. The large coefficient of variation was caused by measurements that were taken during inclement weather on R6-1L signs as shown in Figure 0.18. The presence of water or ice can greatly reduce the signs retroreflectivity efficiency and should be considered during visual assessment or physical measurement of the sign.

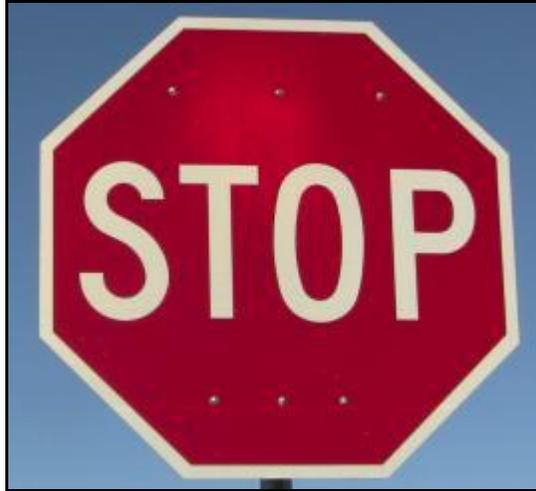
Figure 0.20 Failed Type XI Red Sign

A total of 20 Type XI red traffic signs were measured by the completion of the sample survey. Similar to the other prismatic traffic sign sheeting types the only present issue is the maintenance of the three to one contrast ratio that is required for red sheeting. The only measured failure for Type XI traffic signs was caused by this requirement. On average the background and legend retroreflectivity measurements were 3.17 and 2.25 times brighter than beaded Type III traffic signs. Due to the background retroreflectivity brightness increasing more than the legend this makes it more difficult to maintain the required contrast ratio. The failed sign is shown in Figure 0.20 and it does not seem that the red overlay has experienced excessive fading due to exposure.

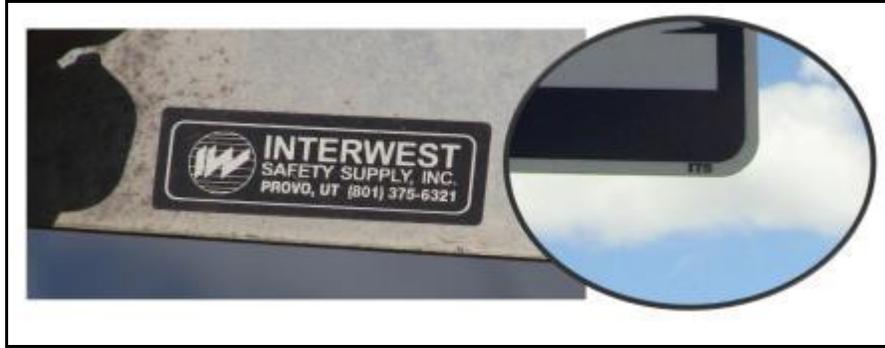
Figure 0.21 Inadequate Installation Sticker

Putting the lack of installation stickers aside there are still various issues with installation stickers found on traffic signs. During the sample survey several instances of newly installed prismatic sheeting were observed with either no installation sticker or stickers that did not provide adequate information. Figure 0.21 displays a sticker found across the state which only displays the name of the company that produced/installed the traffic sign.

Traffic signs under UDOT’s jurisdiction have a variety of installation stickers placed upon them depending on the contractor. Stickers displayed different information and some were susceptible to hole puncher error on both the month and year of installation. It is recommended by the research team that UDOT oversee that development of more uniform stickers that do not require the month and year to be punched into the sticker. The best examples observed in the field were Utah Correctional Industries and Rainbow Sign and Banner. Both of these sticker provided the sheeting type and installation date. Since retroreflective sheeting can begin to deteriorate even when stored in ideal conditions UDOT should look into stamping the date of manufacture into the aluminum backing of the sign, as shown in Figure 0.25. This would ensure that every sign had an installation date, while avoiding the peeling issue observed on some stickers.

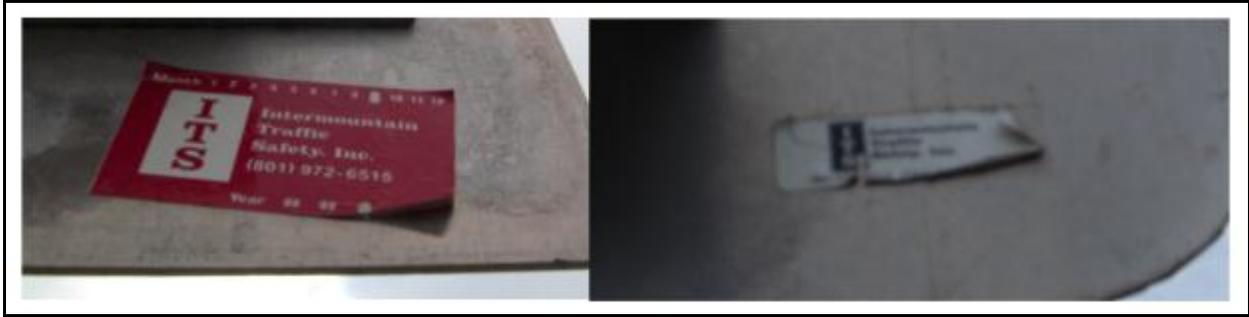
On several traffic signs the installation date was present on the front of the sign but hand peeled off on the pack of the sign or vice versa. If installation stickers are not able to last past the manufacturer's warranty for the specific traffic sign sheeting, then they fail their purpose. Examples of peeling installation stickers are shown in Figure 0.24. Peeling stickers were not very prevalent, but neither were traffic signs with installation stickers. Depending on the management method that UDOT adopts, installation stickers will have different purposes. Regardless of the selected maintenance method adopted by UDOT installation stickers will always be essential in ensuring that the traffic sign exceeded the manufactures' warranty.

Figure0.24 Peeling Installation Stickers

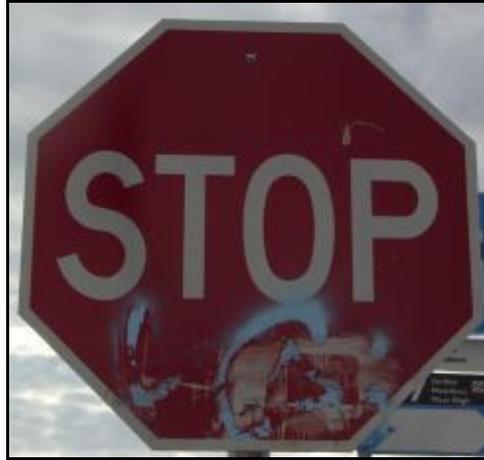
Figure 0.32 Graffiti Cleaner Damage

For sticker and spray paint vandalism researchers observed several cleaning attempts that proved to more detrimental than the original damage. Figure 0.32 displays an example where an attempt was made to clean graffiti off of the sign face resulted in removing the red overlay of the stop sign. Although cleaning the graffiti off of the sign was an attempt to improve legibility of the signs intended message, the end result was a traffic sign that was less legible than before it

was cleaned. For signs that have graffiti an individual assessment is required to determine the severity of message conveyance degradation and decide whether or not a replacement is required.

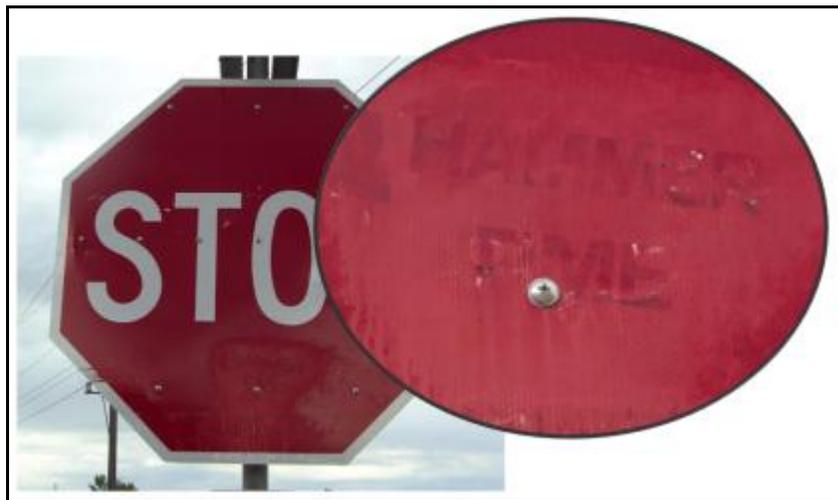
There are other types of vandalism, stickers and paintballs, which are not as detrimental to retroreflective sheeting if proper cleaning techniques are adhered to. Figure 0.33 displays an attempt to remove a sticker which was done with cleaner that damaged the sheeting.

Figure 0.33 Sticker Remover Damage

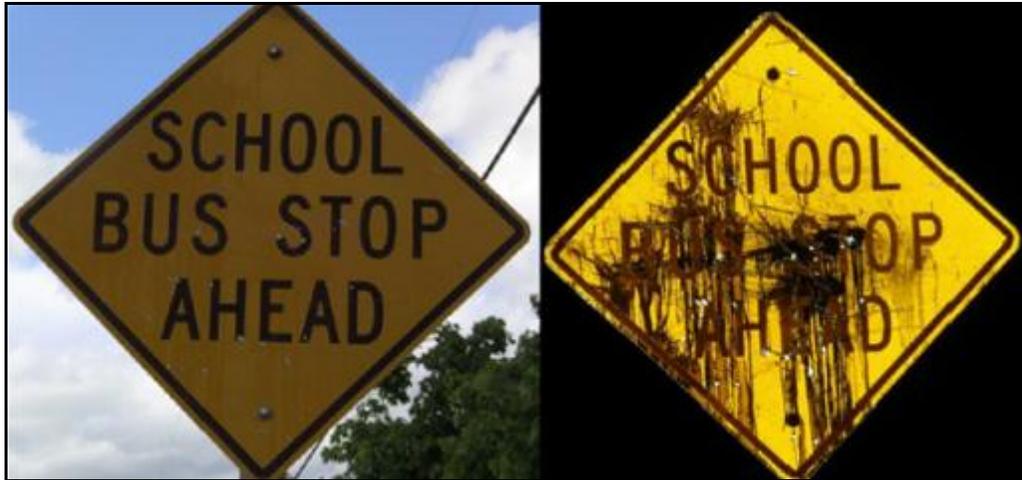
Figure 0.39 Measured Retroreflectivity Day and Night Conditions

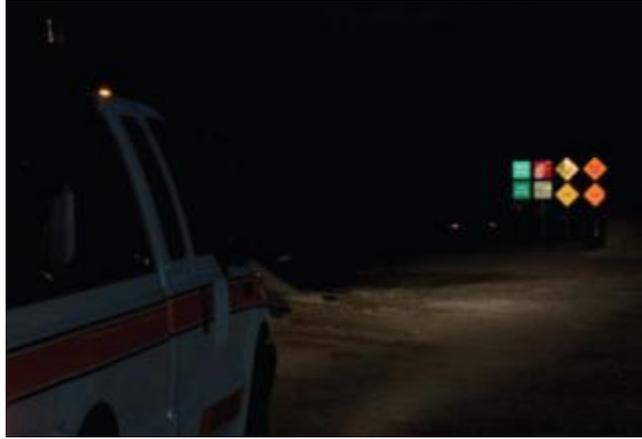
Figure 0.1 Calibration Sign Procedure (36)

For the crew that has the calibration sign the following procedure should be followed. The calibration signs should be setup 300 ft to 500 ft from the front of the inspection vehicle. Depending on UDOT's preference the calibration signs can either be permanently mounted or stored in the protective case. Avery Dennison warrants that even if the calibration signs are permanently mounted that the sheeting will maintain its retroreflectivity for two years (36). In order to ensure the longevity of the calibration signs they can also be taken down and stored indoors. Due to the size and potential need for mobile sign supports the mobility of this procedure is limited. The calibration signs need to be mounted at heights of at least 5 ft and meet all MUTCD guidelines. An example of a calibration sign procedure set up is shown in Figure 0.1.

The inspection crew must wait half an hour after the sun sets to ensure proper darkness for inspection. During this time the inspectors should setup the calibration signs 300 ft to 500 ft from the front of the inspection vehicle. Signs should always be viewed at distance of 500 ft if the calibration area has adequate space. The inspectors will calibrate their eyes for two minutes and ensure that the Trimble or mobile app device has an adequate charge and charging equipment. Once the minimum of two minutes has passed the inspection crew can begin the visual nighttime inspection. During the inspection if a traffic sign appears to be below minimum standards the inspectors will stop the vehicle next to the sign support. Using a customized data dictionary in the Trimble or mobile app the crew will take a GPS point and record the color, MUTCD code, sheeting type, and installation date (if present) of the sign.

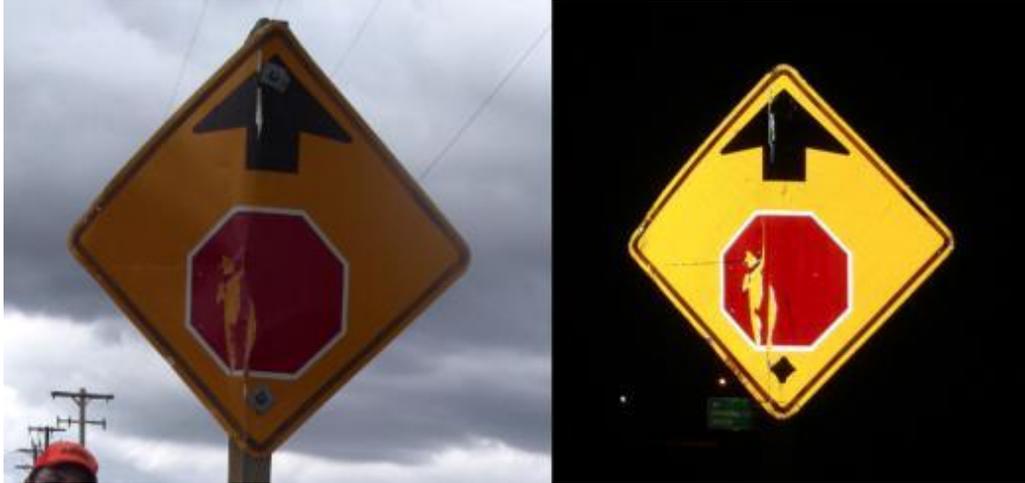
Figure 0.2 Failure Due to Damage

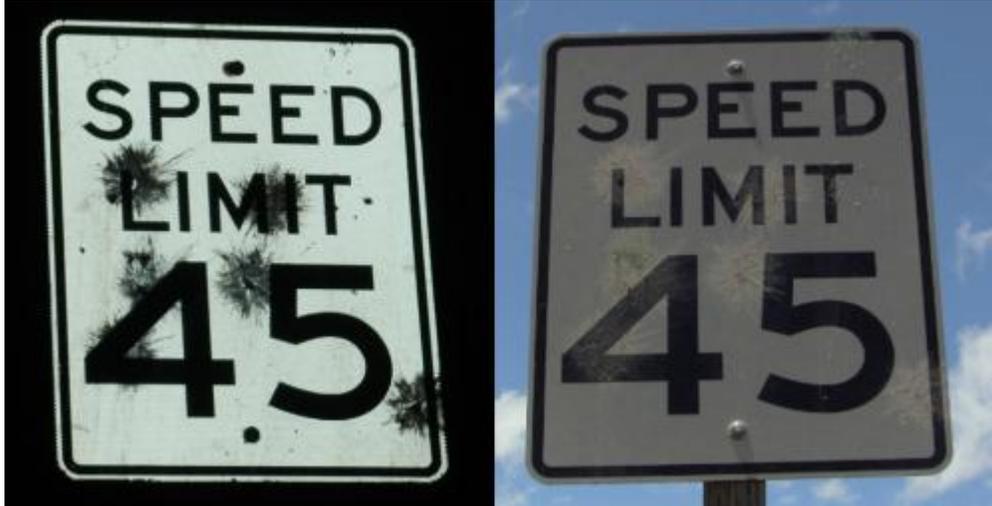
Figure 0.3 Paintball Damage

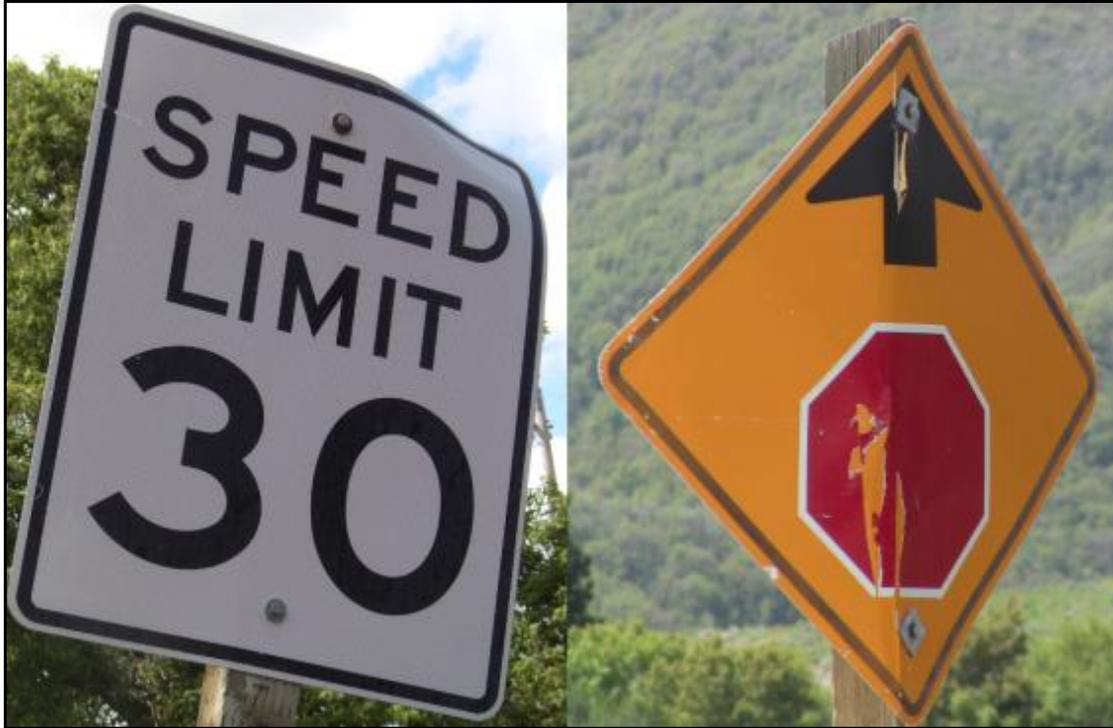
Figure A.1 Examples of Minor and Major Bending Damage

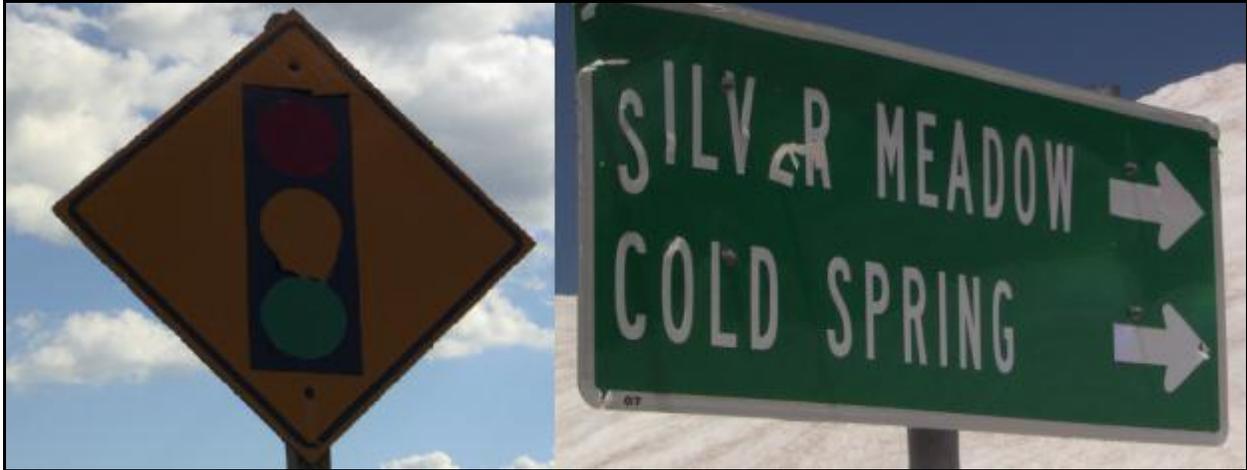
FigureA.2 Examples of Minor and Major Peeling Damage

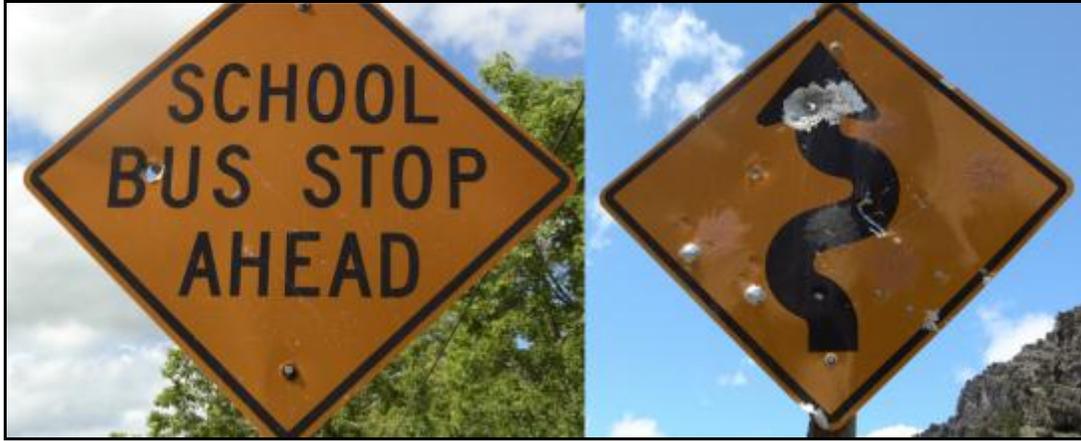
FigureA.3 Examples of Minor and Major Projectile Vandalism

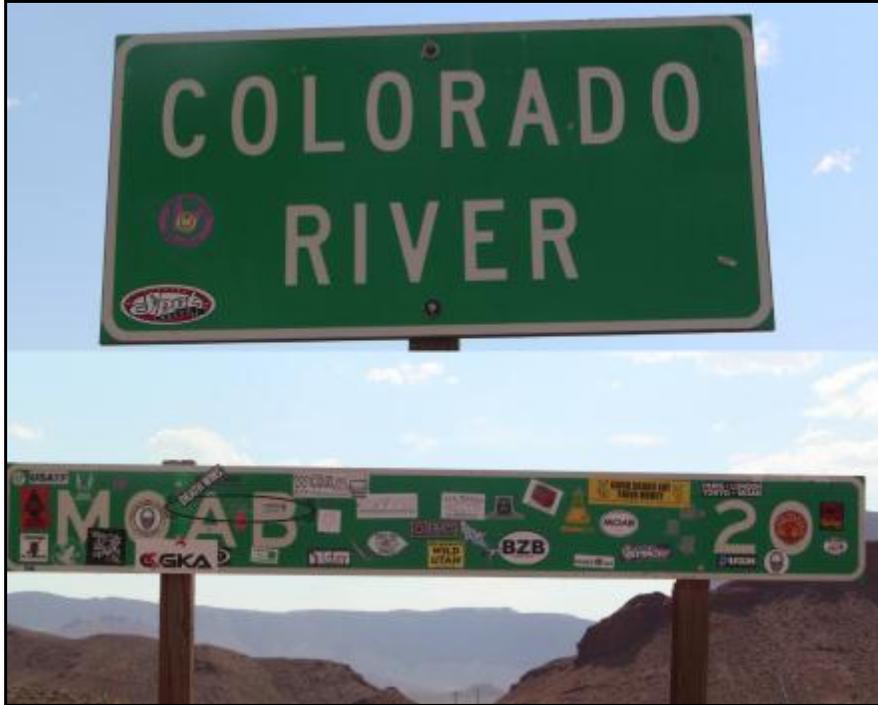
Figure A.4 Examples of Minor and Major Locality Vandalism

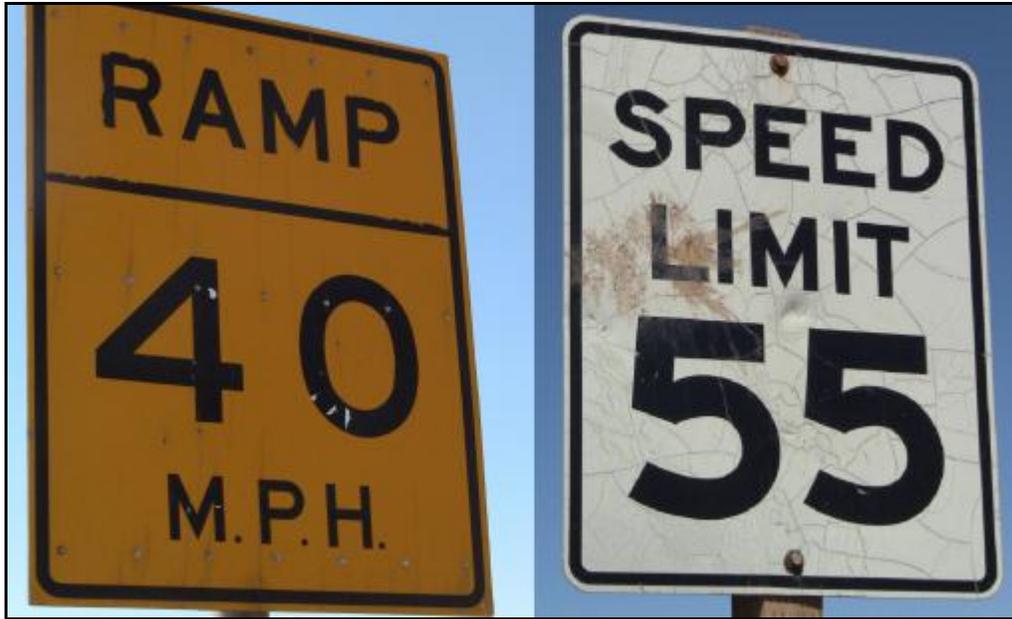
Figure A.5 Examples of Major Cracking Damage

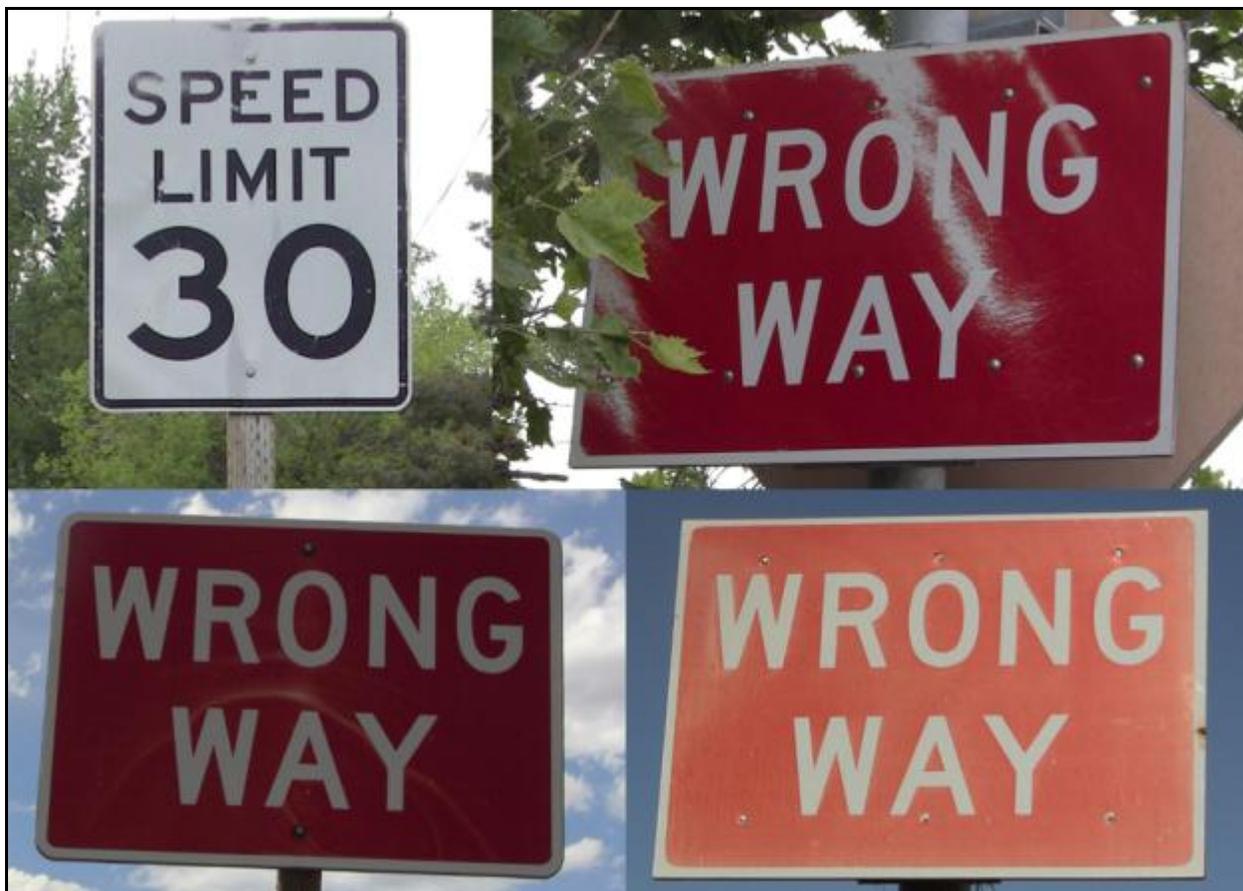
Figure A.6 Examples of Minor and Major Other Damage
